Appendix I: Example of Student Work

Submission for Course Assignment 1: Ecolos Cable Ferry Failure

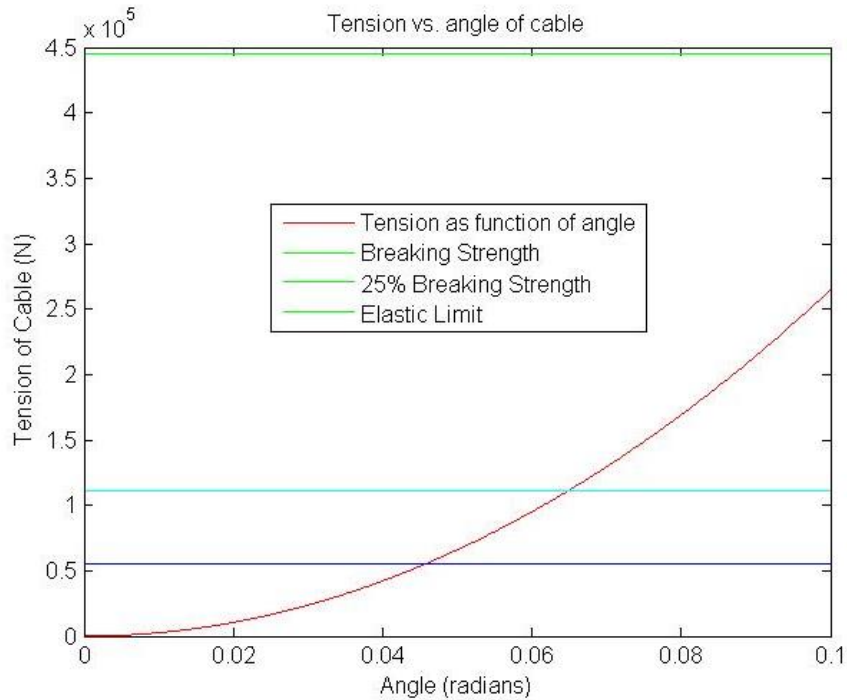
Figure 2: Relationship between angle of the cable to its tension.

Figure 2(left) displays the relationship of the tension of the cable to the angle of the cable. The green line at the top is the normal breaking strength as reported by the ferry manufacturers. The cyan line below is the cable at 25% normal breaking strength and the blue line is the elastic limit or point at which the cable stopped acting as an elastic material. When the angle reaches around 0.045 radians it can be seen that it crosses the tension as a function of

angle. This shows the point at which the cable would have snapped if the cable were at 25% breaking strength.

From the plots in figure 2 it can be concluded that if the cable was at 25% breaking strength the day of the accident than this is an accurate model of the failure. As the angle the cable makes with the wall increases, the tension in the cable increases. Once the angle made with the wall reaches approximately 0.045 radians, there is enough tension in the cable to break, which would lead to the ferry being detached from the system. The force that causes this change in angle will be analyzed more thoroughly in the next more complex model.

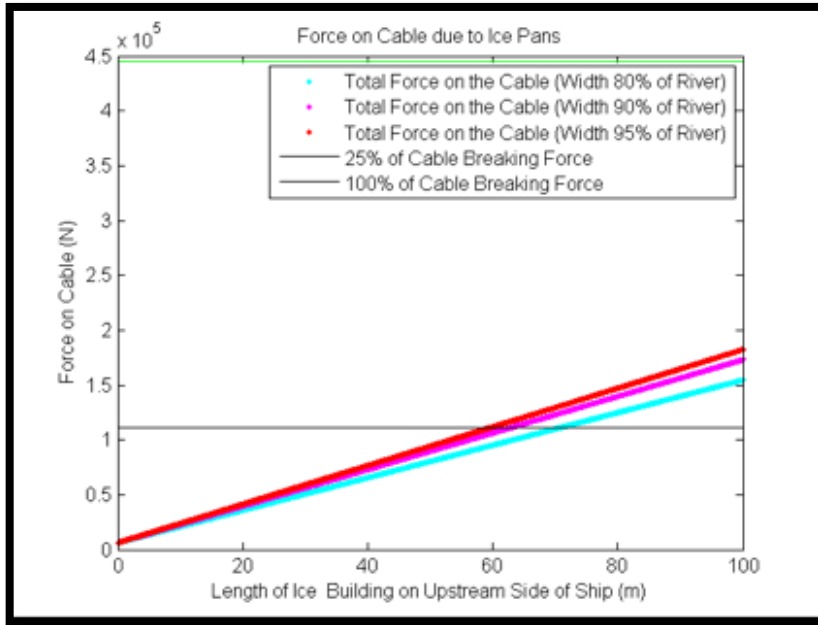
Figure 5: Length of Ice vs. Force on Side of Ship as graphed using MATLAB.

Force was plotted as a function of the length of the ice. Force values corresponding to 25% and 100% of the cable's breaking strength were included in the graph using MATLAB.

To account for the uncertainty in the width of the ice block (information from the preliminary investigation report said that ice slush and pans accounted for about 90% of the river's surface), graphs for multiple values for the width of the ice block were included.

Solving for the value of the length of the ice 'block' algebraically gives a value of 63.216m for the length of the ice block when the force on the cable meets 25% of the cable's breaking force.
