Appendix I: Example of Student Work

Submission for Course Assignment 1: Ecolos Cable Ferry Failure

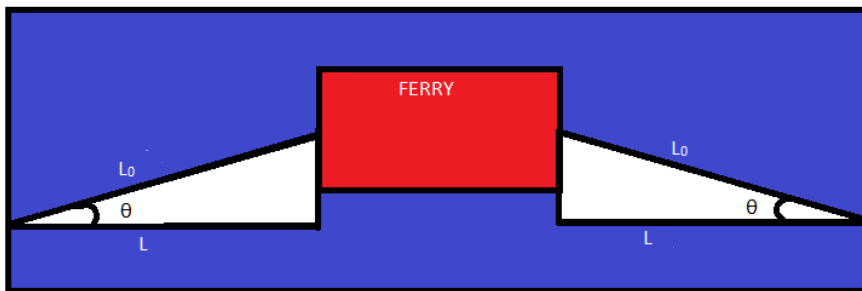
Figure 1: diagram of simple MATLAB model scenario.

In figure 1(left) a model of the Ecolos ferry is seen as a force is applied against it causes the cables to stretch and the angle of the cable to the wall to increase. The first model is based on the mathematics of the angle between the cable’s new direction and it’s original

direction, where L_0 is the final position of the cable after a force has been applied, L is the length of the cable at its normal operating position and θ is the angle at which the cable makes with the shore. With Figure 1 a trigonometric relationship between θ , L_0 and L can be seen, as shown in equation 1.

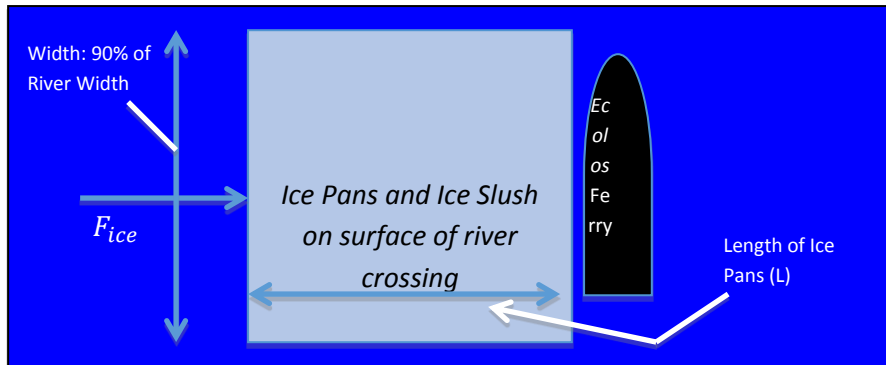
Figure 3: Diagram of force exerted on Ecolos Ferry by ice slush and pans.

The first model represents the force of the ice on the boat as a function of the length of the ice slush and pans extending from the upstream side of the ferry. Additionally, water exerts a force on the area of the boat submerged due to form drag.

Combining these two forces, which both act in a downstream direction on the boat, yield the equation:

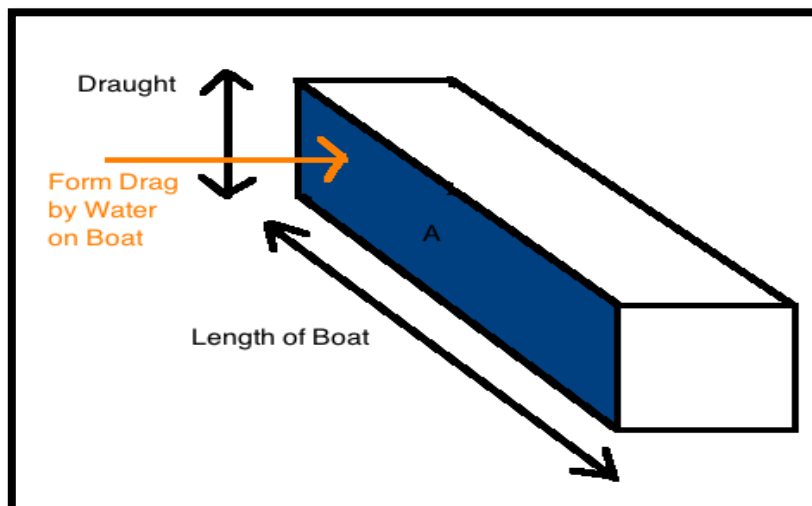
Figure 4: Diagram of force exerted on Ecolos ferry by flowing water (form drag)

Where the two terms on the right side of the equals sign correspond to the form drag force on the boat, and the surface drag force on the ice, respectively. In this model, rigid ice has accumulated on the upstream side of the ship. Water exerts a force on the ice, which is translated on to the ship, exerting a force on the cable. Note that the form drag force on the boat remains constant, as the submerged area of the boat perpendicular to the water flow does not change.

Multiple assumptions are made with this model. Firstly, it is assumed that the width of the ice is equal to 90% of the width of the river. This assumption is based on the observation that the ice sheets covered 90% of the river surface, as reported in the Preliminary Investigation Team Report on *Ecolos* Cable Failure. The force on the ice due to surface drag by water is assumed to be negligible in this model. Given that the plane of ice perpendicular to the flow of water was only millimetres in depth at the time of the failure, the drag force on the ice would not have exceeded roughly 20N. This pales in comparison to the other forces acting on the cable, which reach tens of thousands of newton's. Additionally, the mass of ice sheets and pans is assumed to be a uniform, rectangular block, all with the same surface drag coefficient of 0.01 (that of rough ice). The plane of the boat that the form drag due to water acts on is assumed to be perpendicular to the direction of the current. It therefore has a form drag coefficient of 1.28. Lastly, the density of the water is assumed to be $\frac{1000kg}{m^3}$.
